City of Wilmington Pedestrian Safety Study

Wilmington Pedestrian Audit

South Market Street: New Sweden Street to 16th Street

July 14, 2023

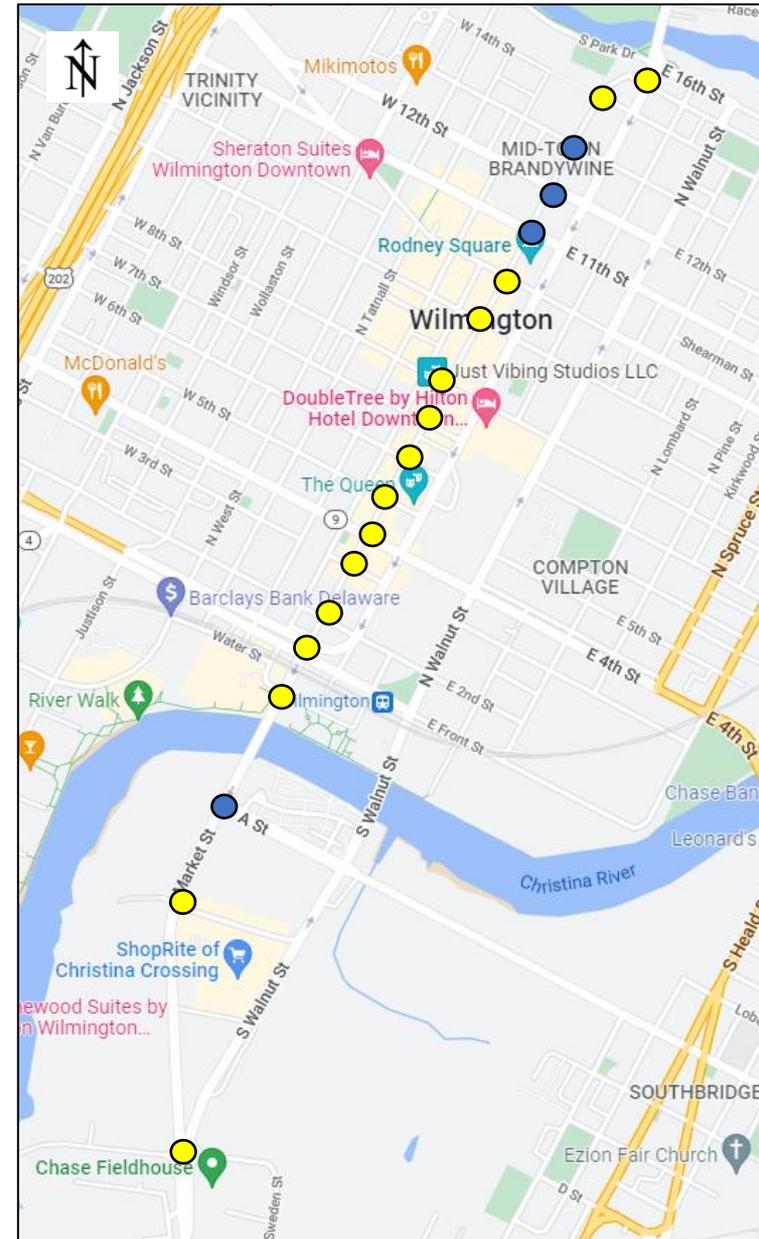
Lighting Evaluation

- Qualitative driving assessment
- Streetlamps and LED luminaires are common
- Midblock lighting is adequate except between:
 - 14th St and 15 St
 - A St and 0.2 miles north of New Sweden St
- Lighting deficient on four crosswalks:
 - S Market St at A St – East leg
 - S Market St at 11th St – East leg
 - S Market St at 12th St – East leg
 - S Market St at 13th St – East leg
- Streetlamp out on SE corner of South Market Street and 12th Street

- Install TURNING VEHICLE YIELD TO PED signs (R10-15) at signalized intersections where RTOR / LTOR is permitted and/or where left turns are permitted
- Upgrade existing pedestrian heads with no countdowns to include countdowns where missing
 - S Market Street at Howard Street (2)
 - S Market Street at 2nd Street (4)
 - S Market Street at 4th Street (2)
 - S Market Street at 11th Street (1)
 - S Market Street at 12th Street (1)
 - S Market Street at 13th Street (8)
 - S Market Street at 14th Street (1)
- Refresh faded crosswalks
 - S Market Street at Howard Street east leg
 - S Market Street at 10th Street south leg
 - S Market Street at 13th Street east leg
- Consider lighting improvements at deficient locations

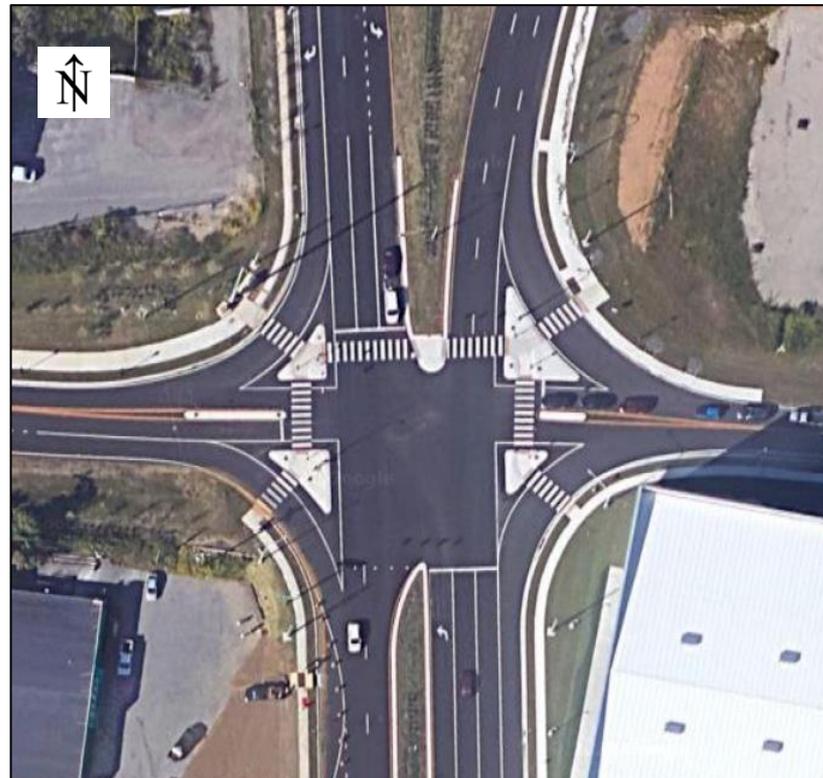
- **One crash** involving a SB vehicle running over the curb and striking a pedestrian on the sidewalk
- Pedestrian signals on the north, east, and west legs
- New signalized intersection, activated in 2020

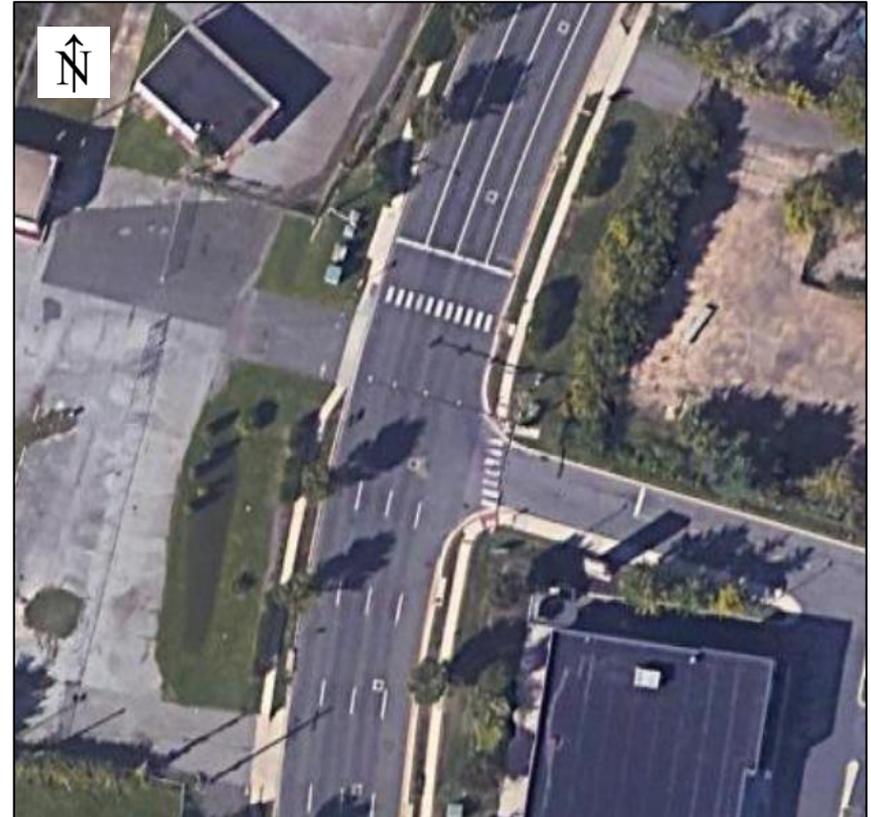
- **Zero crashes**
- Pedestrian signals on the north and east legs
- Shopping plaza located on Howard Street
- Faded crosswalk pavement markings on east leg
- During observations, the pedestrian signal on NW corner did not display the Walk symbol

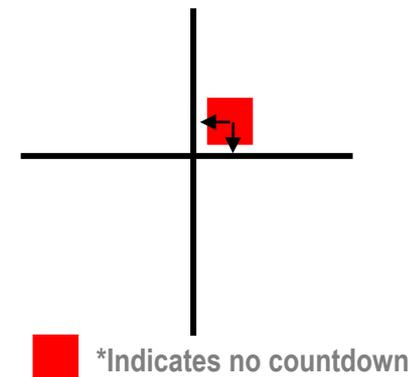
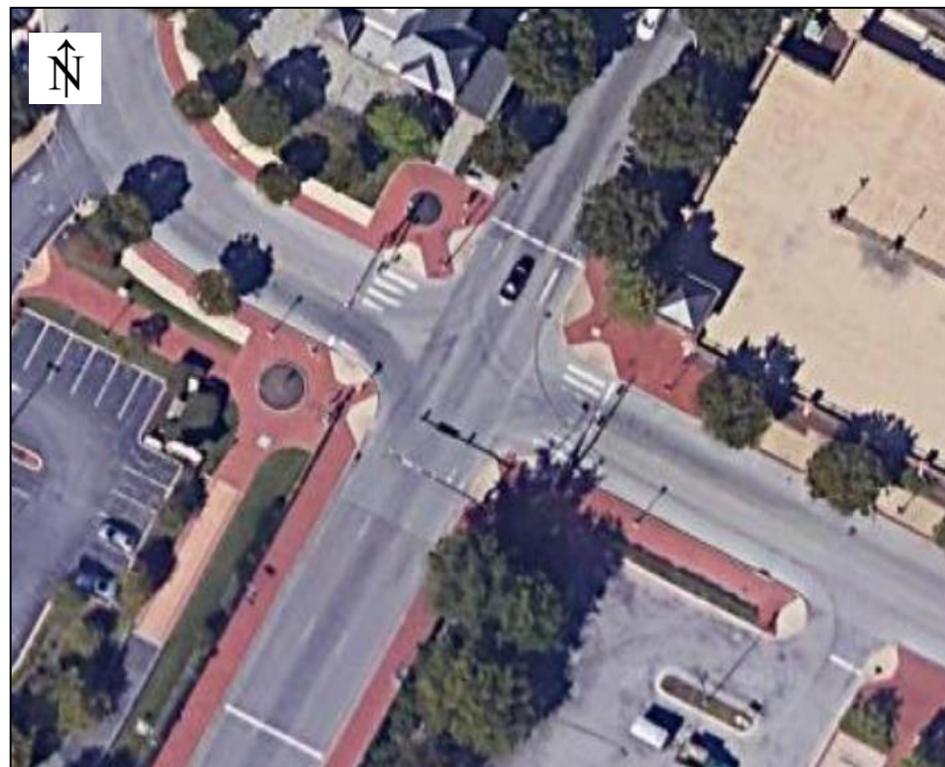
S Market Street at Rosa Parks Drive

- Pedestrian signals on all four legs
 - Faded crosswalk markings
- Bus stop on NW corner of intersection
- Adjacent to Wilmington Train Station
- Midblock pedestrians observed crossing north of the intersection
- Bus stop on NW corner of intersection
- Two existing ped heads have no countdowns

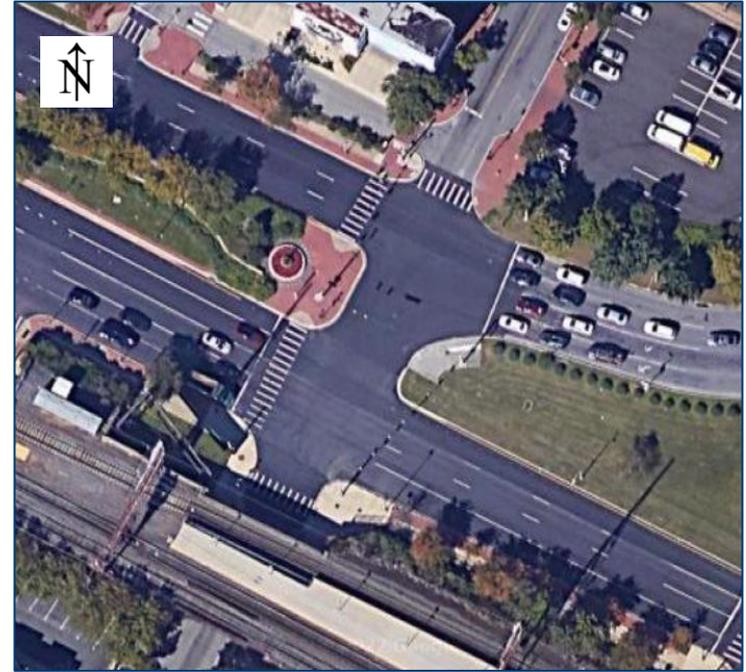
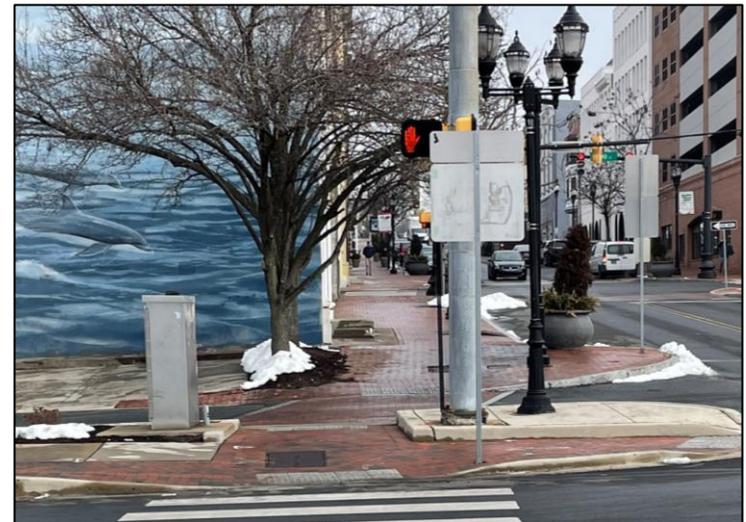
- Pedestrian signals on north, south, and west legs
- Observed pedestrians on south leg crossing against the signal
- Pedestrian observed walking diagonally through crossover
- Turning Vehicles Yield to Peds sign facing EB traffic
- Ped head on NW corner is partially blocked by sign
- As part of 2018 HEP Site E, a right-turn-on-red restriction was recommended on the EB approach, along with a LPI (Leading Pedestrian Interval) for the south leg

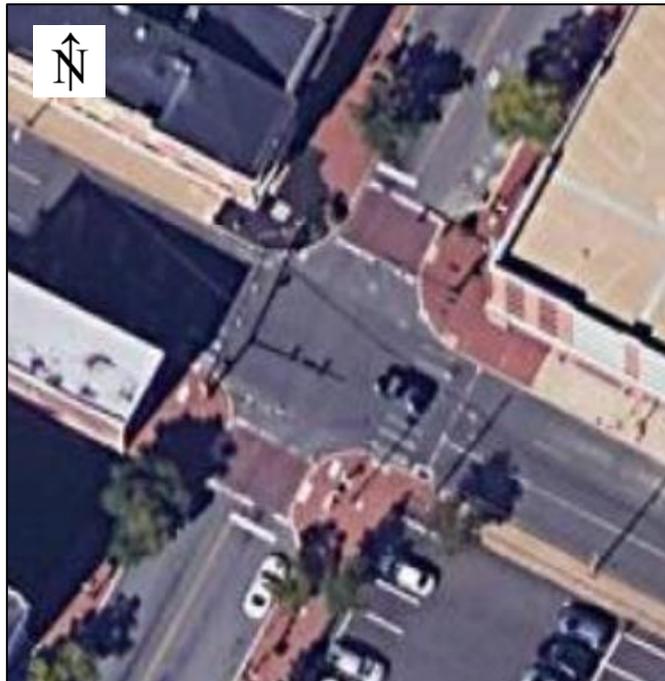
S Market Street at 2nd Street

- Includes two decorative brick crosswalks and two striped crosswalks, all in good condition
- Four existing ped heads have no countdowns

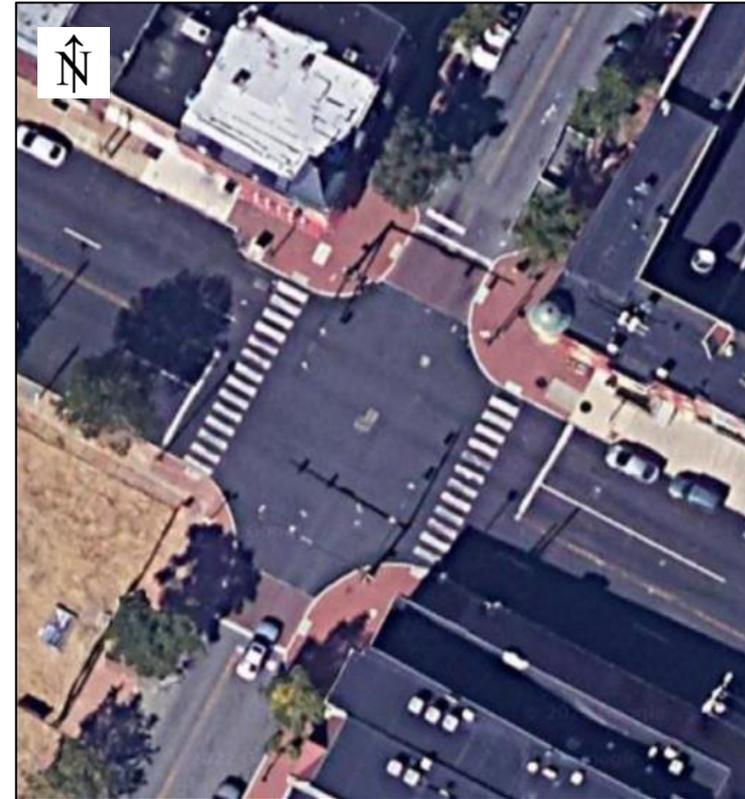
S Market Street at 4th Street

- Pedestrian signals on all four legs
- Observed pedestrians on north and south legs crossing against the signal
- Two existing ped heads have no countdowns

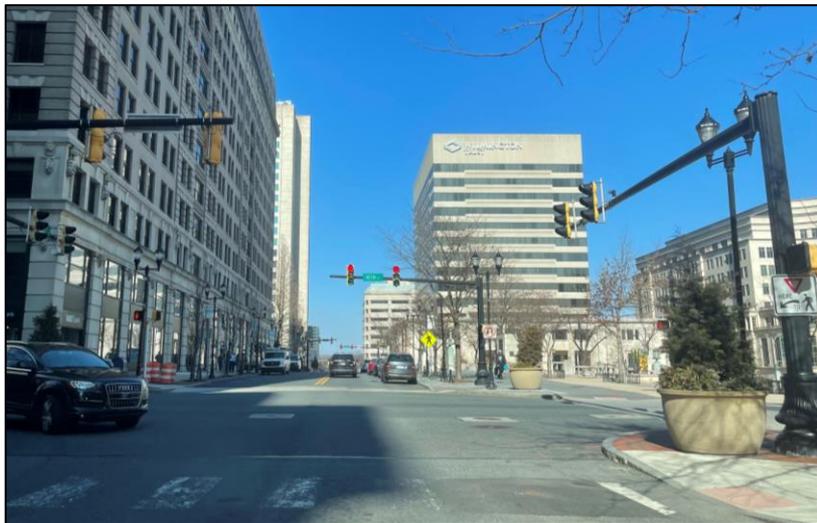
- Faded crosswalk on S leg
- Potholes in E and W leg crosswalks
- Observed many midblock crossings and pedestrians crossing against the signal

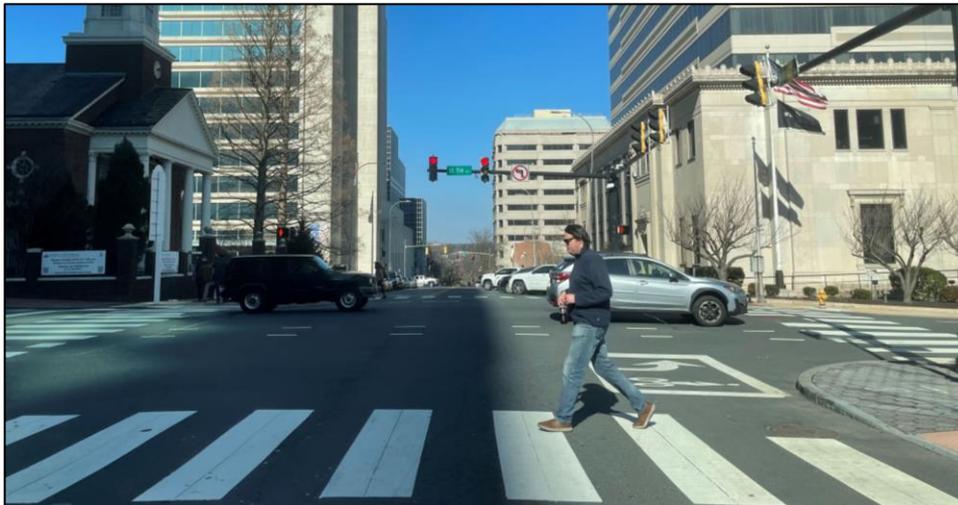
- Observed pedestrian crossing against the signal on the E leg (not shown)

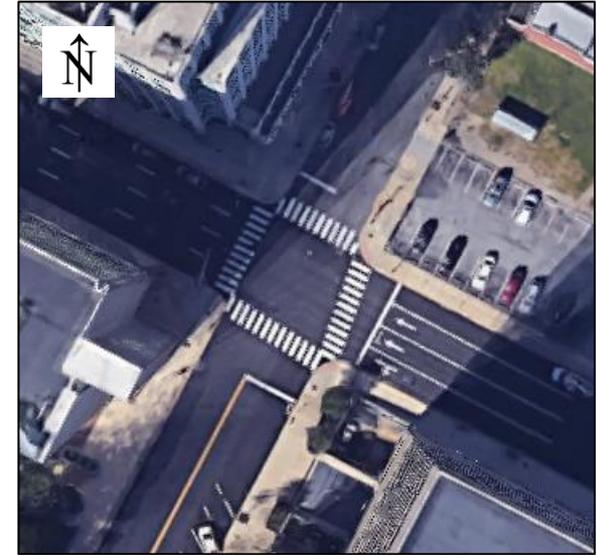
- Missing ped heads on SE corner of intersection
- Observed a pedestrian crossing against the signal on the W leg

- Install missing pedestrian signal
 - S Market Street at 12th Street SE corner
- Repair decorative brick crosswalk on the W leg of S Market Street at 10th Street
- Repair broken pedestrian signal on the SW corner of S Market Street at 13th Street
- Switch controller setting to “Rest in Walk” on the NE corner pedestrian signal at S Market Street and 14th Street
- Consider a Leading Pedestrian Interval (LPI) for the east leg crosswalk at S market Street at 4th Street due to SBL pedestrian crashes

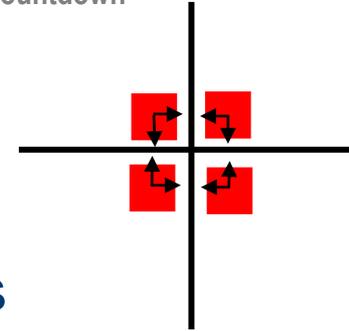
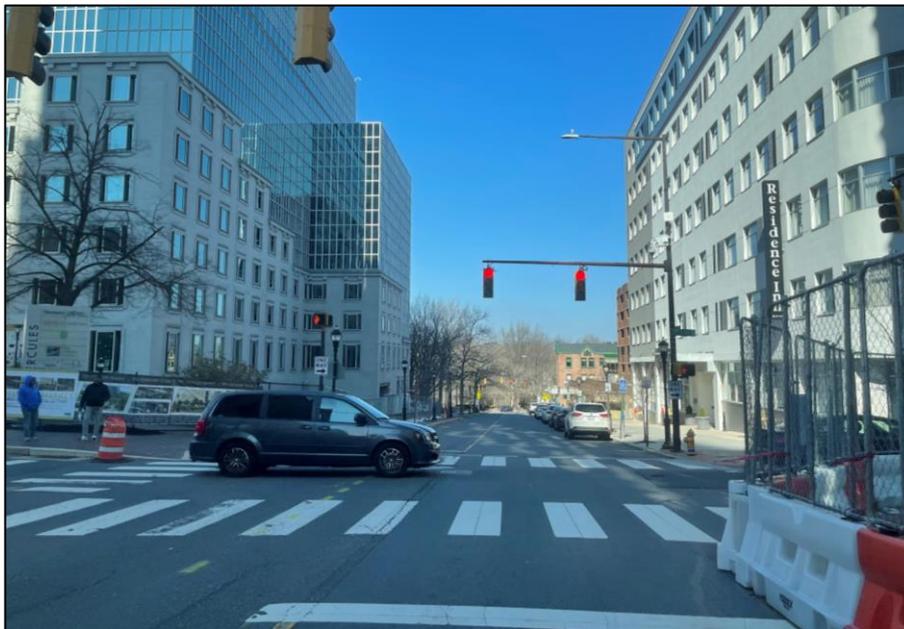
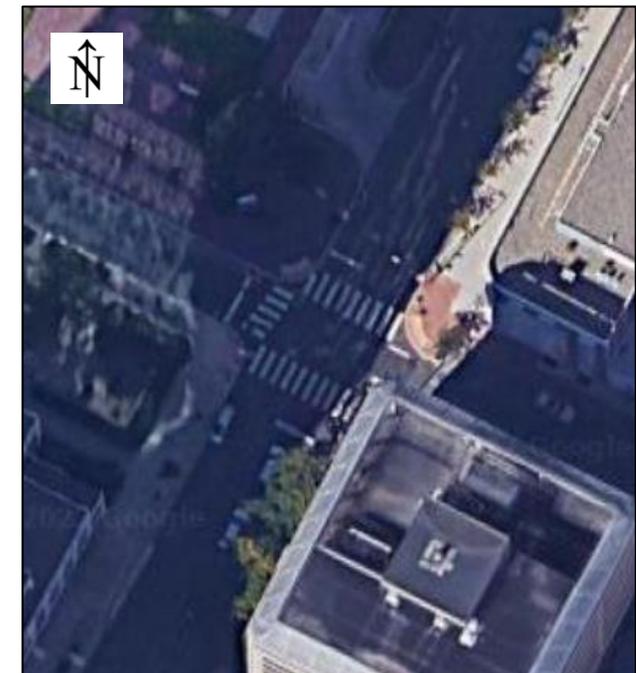
S Market Street at 13th Street

- Zero crashes
- Marked crosswalks across all four legs
- Faded E leg crosswalk
- No countdown displays on any pedestrian signals
- Ped signal on SW corner is not working
- Peds were observed crossing midblock N of the intersection

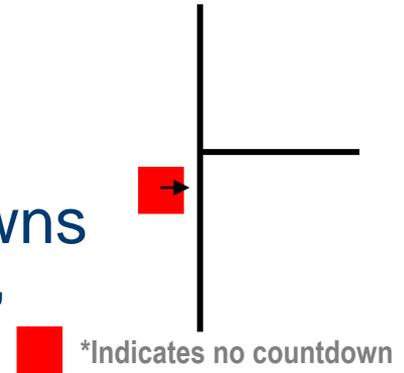
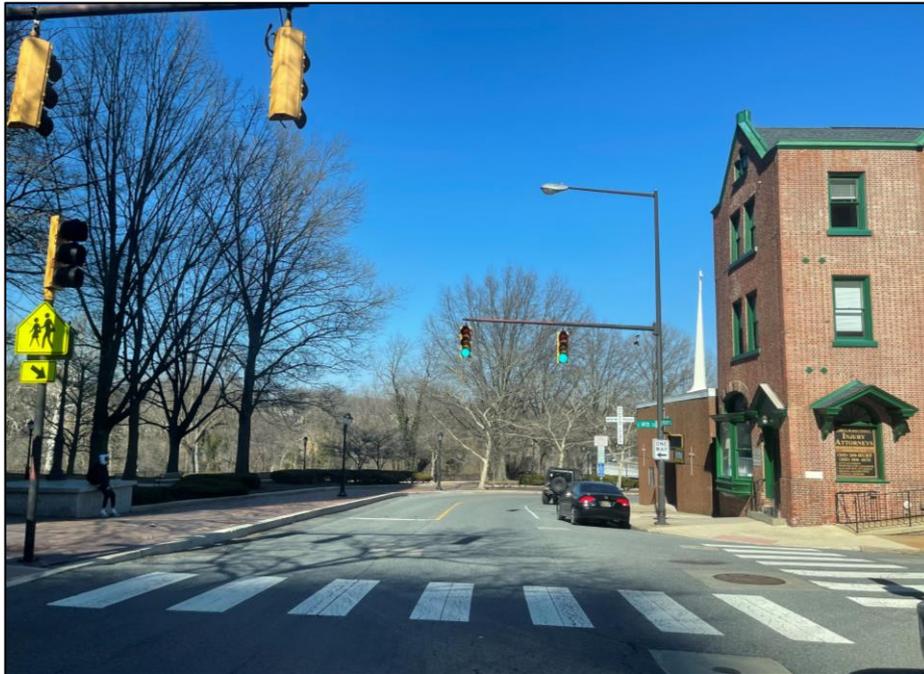
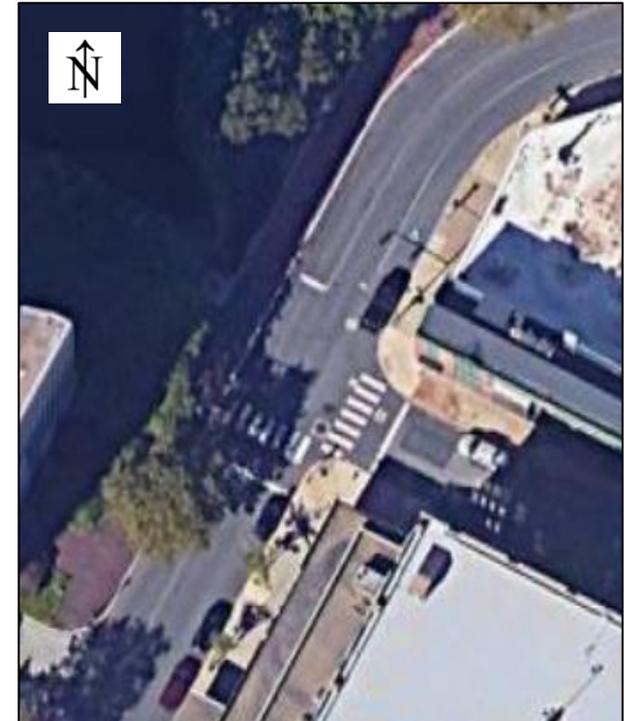
S Market Street at 14th Street

- Zero crashes
- Marked crosswalks across S and E legs
- One existing ped head does not have countdowns
- Ped signal on NE corner does not “rest in walk”
- School crossing assemblies at S leg crosswalk

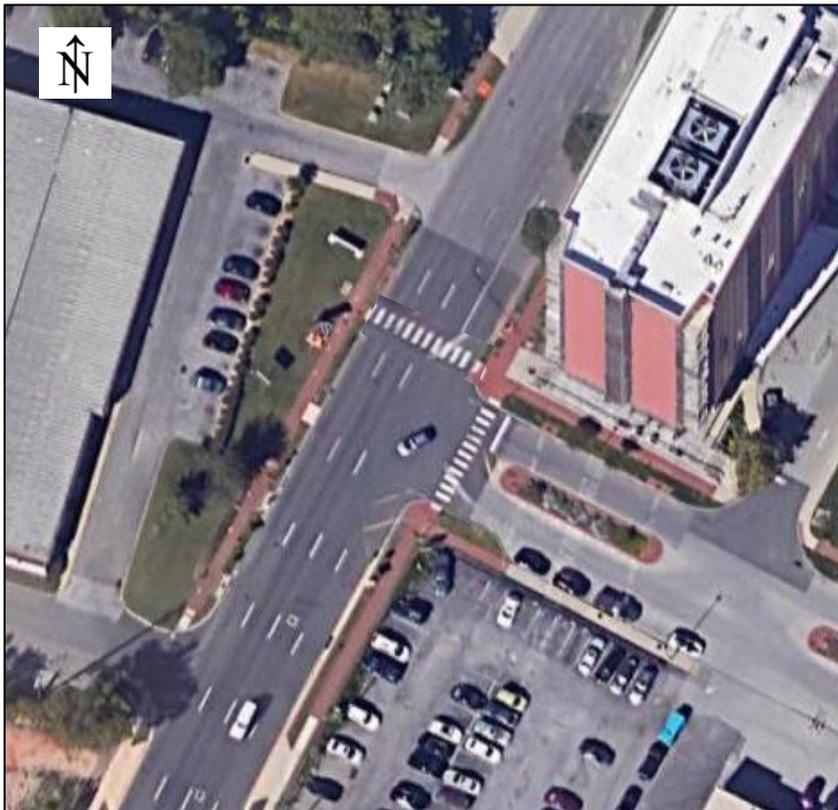
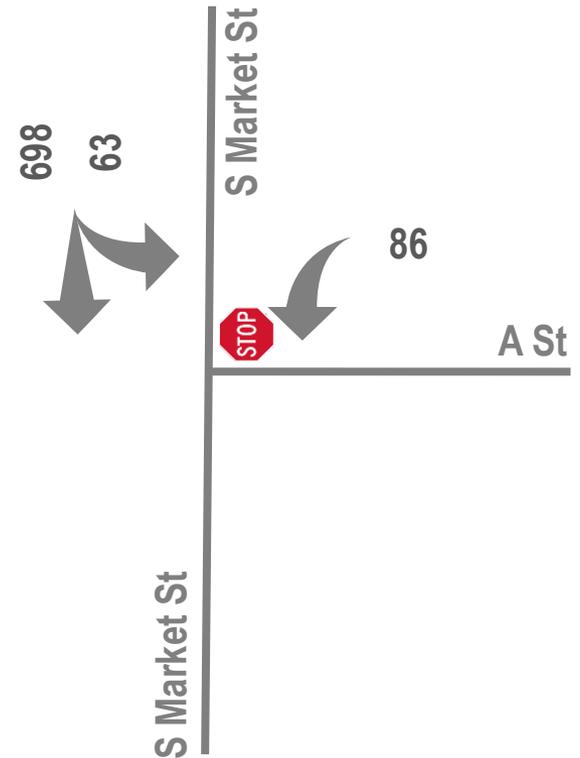
S Market Street at A Street

- **One crash** involving a WBL vehicle striking a pedestrian in the crosswalk
- Two existing marked crosswalks

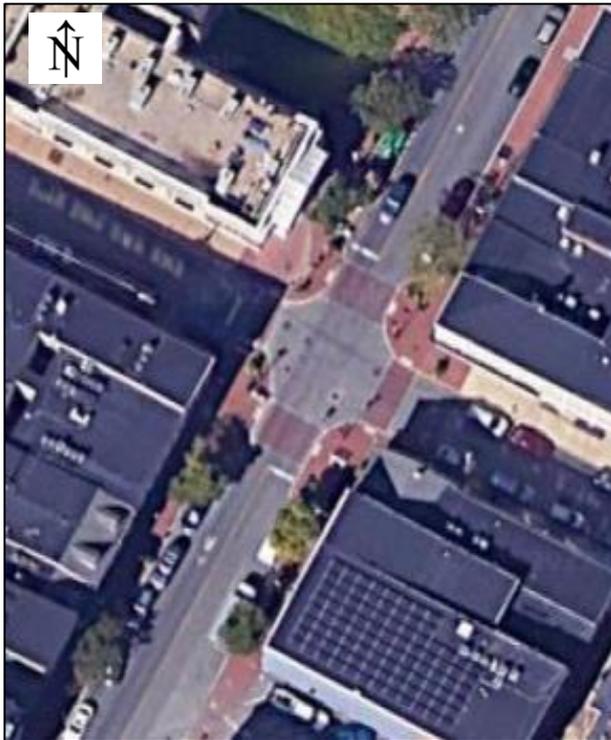
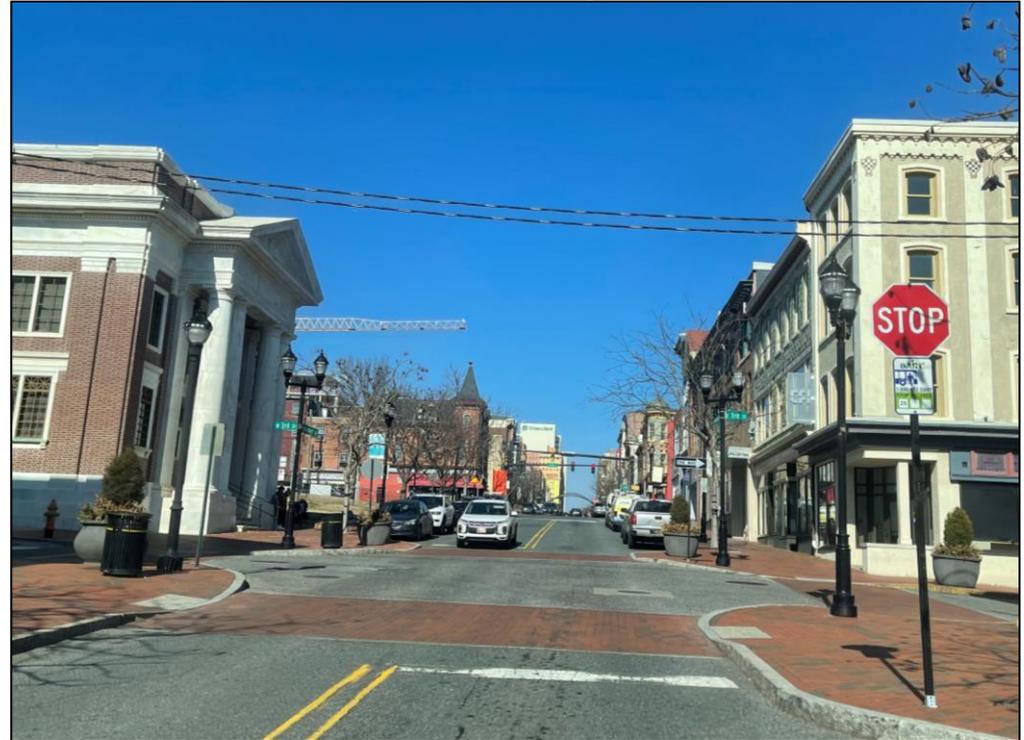
- Zero crashes
- Four existing decorative brick crosswalks
- 3rd Street is one-way
- Bus stop located on SE corner
- STOP signs on north, south, and west legs

- Install pedestrian crossing warning signage at unsignalized intersections
- Install ALL WAY (R1-3P) plaques beneath STOP signs at the following unsignalized intersections
 - S Market Street at 3rd Street
 - S Market Street at 6th Street
 - S Market Street at 8th Street
 - S Market Street at 9th Street
- Replace 4-WAY plaques on STOP assemblies with ALL WAY (R1-3P) plaques at S Market Street at 5th Street
- Replace 3-WAY plaques on STOP assemblies with ALL WAY (R1-3P) plaques at S Market Street at 7th Street
- Consider bumpouts at intersections between 10th Street and 15th Street to reduce crosswalk lengths

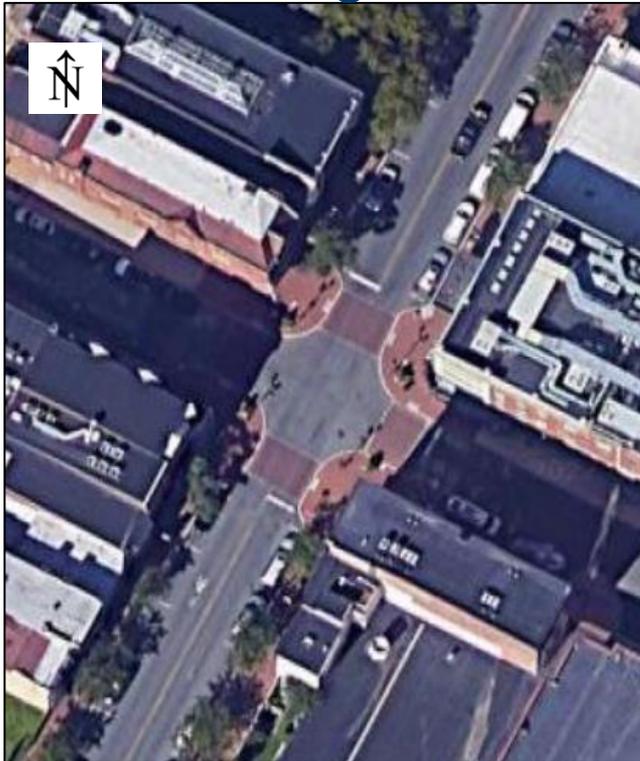
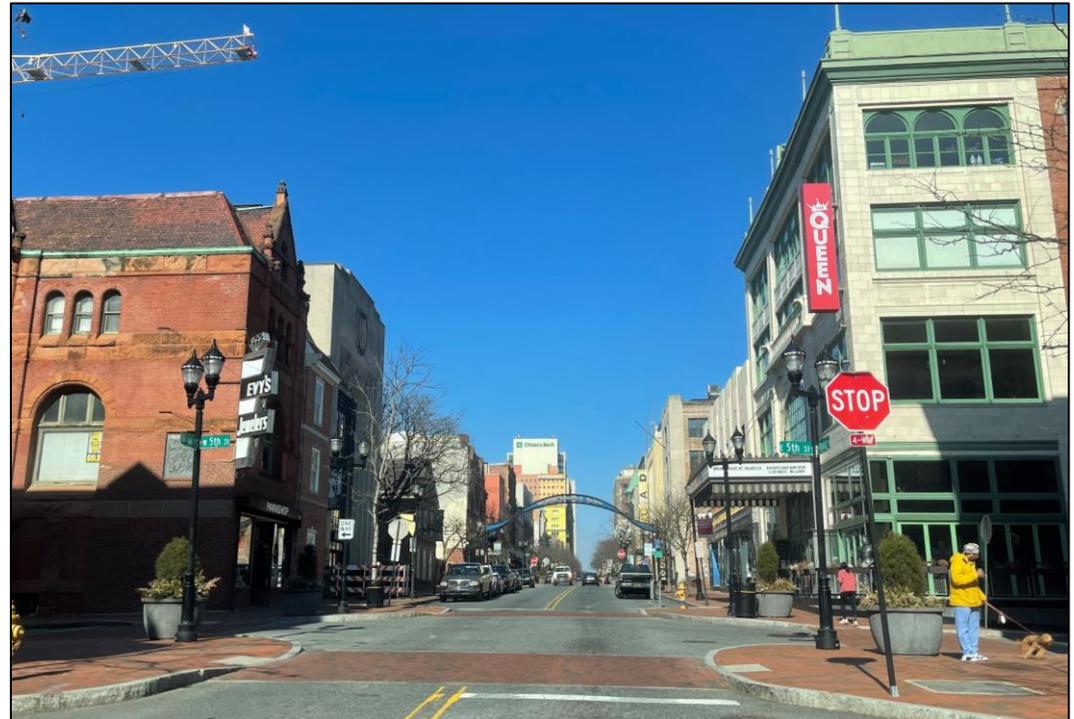
S Market Street at 5th Street

- **One crash** involving a SBR vehicle failing to yield and striking a pedestrian in the crosswalk
- Four existing decorative brick crosswalks
- 5th Street is one-way
- STOP signs on north, south, and east legs

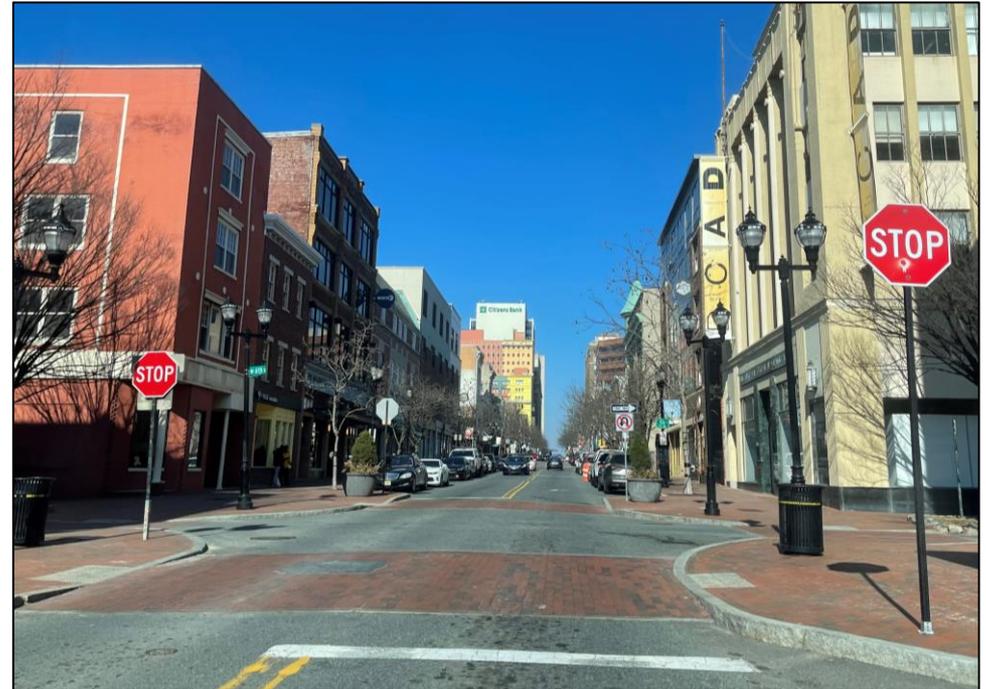
- 2 NB vehicles struck pedestrians crossing midblock
- 1 EB vehicle failed to yield and struck a pedestrian in the crosswalk
- Four existing decorative brick crosswalks
- 6th Street is one-way
- STOP signs on north, south, and west legs

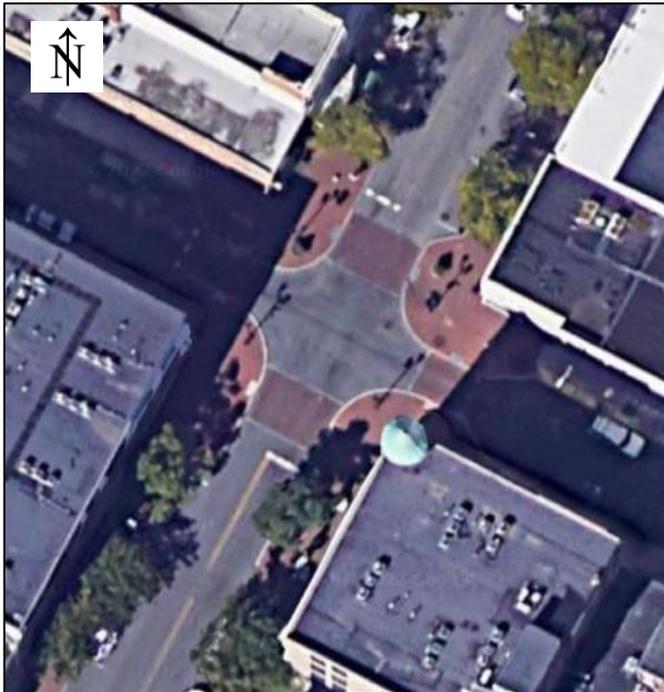
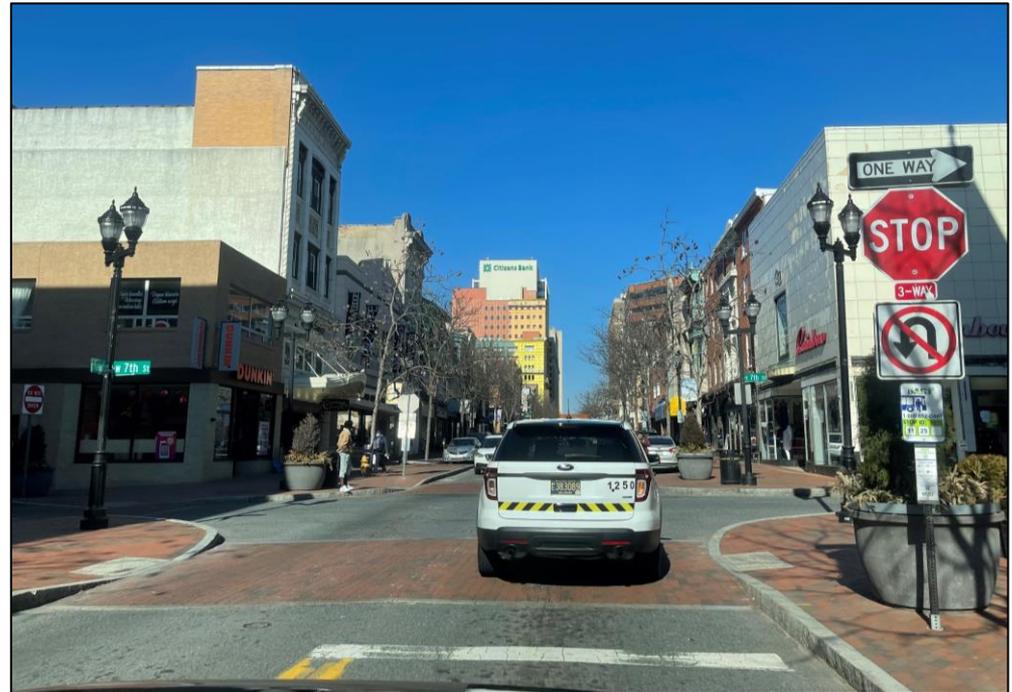
- 2 NB vehicle reversed into pedestrians crossing midblock
- 1 NB vehicle struck a pedestrian crossing midblock
- Four existing decorative brick crosswalks
- Bus stop located on SE corner
- STOP signs on north, south, and west legs

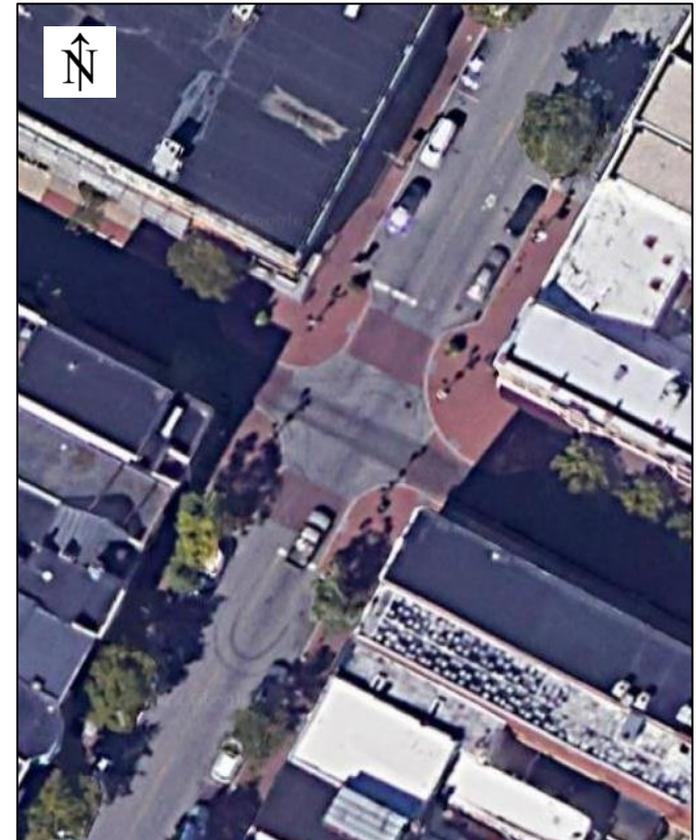
S Market Street at 8th Street

- Observed many peds crossing on each leg
- Observed paratransit bus stop in SB lane
- STOP signs on north, south, and east legs
- “Yield to Pedestrians” plaque on NB and SB STOP sign assemblies
- Four existing decorative brick crosswalks
- W leg crosswalk is in poor shape
